MEMORANDUM

Date: February 1, 2018
To: City of Richfield
From: Bryan Nemeth, P.E., PTOE
Subject: Traffic Analysis Evaluation: Existing Conditions - DRAFT Lyndale Avenue Reconstruction City of Richfield, Hennepin County, MN Project No.: T16114541

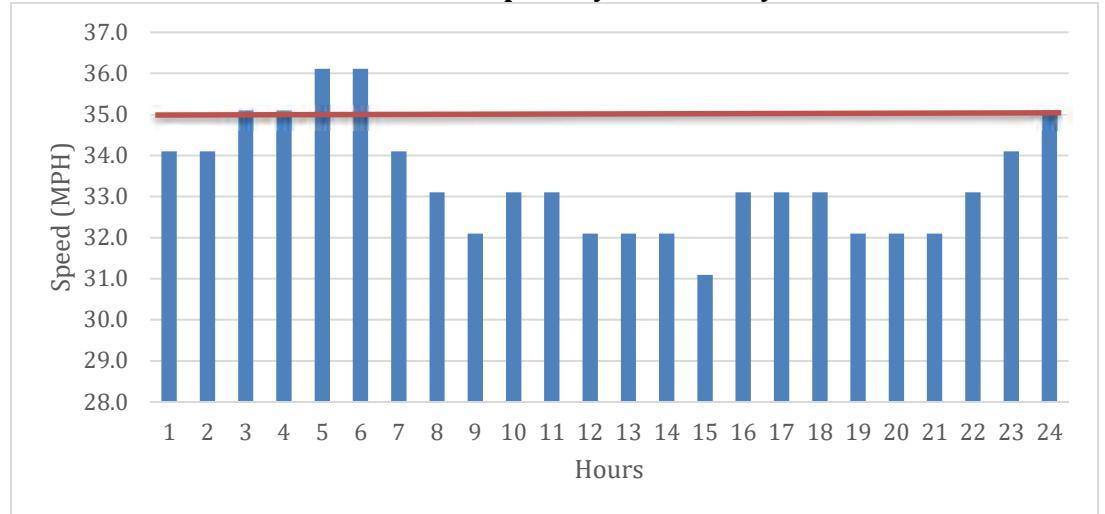
The speeds also vary over the day. Generally, speeds are higher during the non-peak hours due to lower traffic volumes and less congestion. During times of low volume to capacity ratios, the speeds are less influenced by the traffic volumes and are more influenced by the roadway features. Lower speed on the south end of the corridor through the commercial area and higher speeds between the commercial areas. The red lines indicate the speed limit.

The speeds indicate that there is concern with speeding on the corridor between the commercial areas, primarily between 67th and 75th Streets.

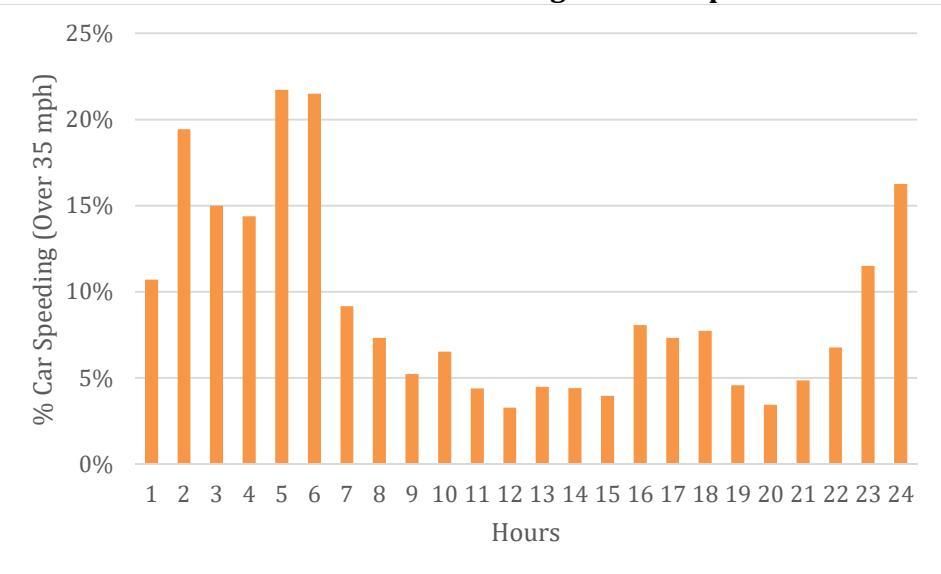
Location 1: % of Vehicles Traveling Over the Speed Limit

At the northern location, between the commercial areas, 50% of the traffic is traveling faster than the speed limit 5 hours of the day and 15% of the traffic is traveling faster than the speed limit all hours of the day.

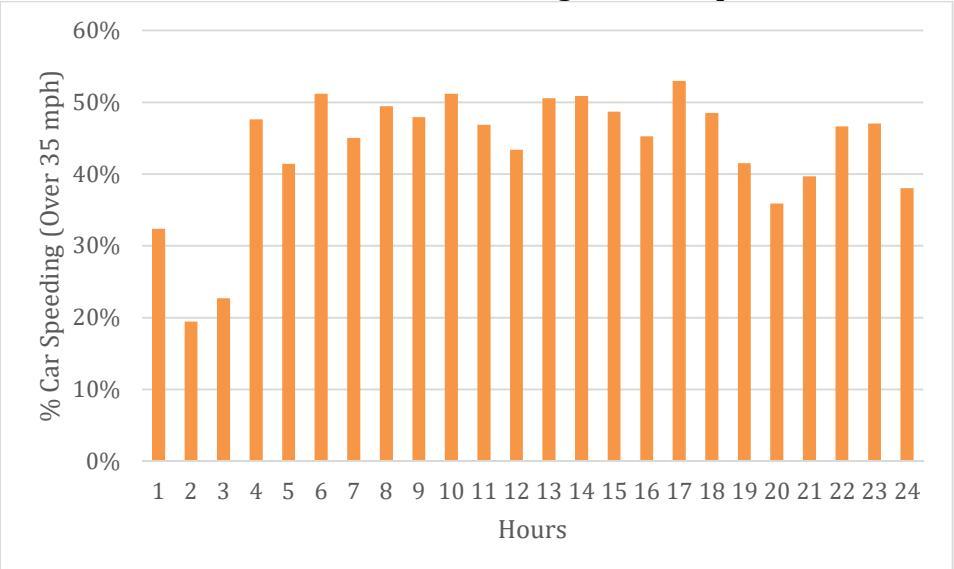
Location 2: % of Vehicles Traveling Over the Speed Limit

Even with the lower speeds that are experienced at the southern location, up to 20% of the traffic is traveling faster than the speed limit between 5-7 am with over 10% of the traffic traveling faster than the speed limit between 11 pm and 7 am.

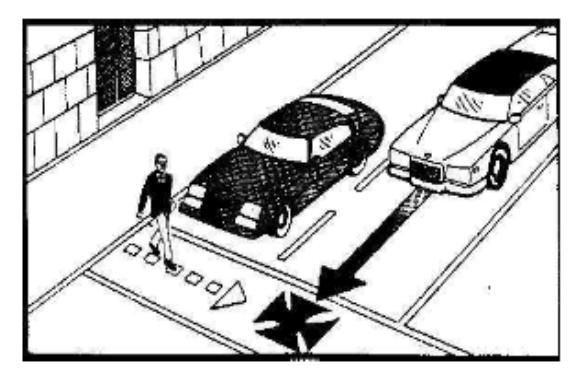
four-lane undivided roadway section resulted in traffic stopping for the pedestrian in the right lane but the stopped vehicle blocked the view of the pedestrian from the adjacent lane. When there are multiple travel lanes on each approach there is a higher occurrence of crashes due to the multiple threat posed. A reduction in multiple travel lanes can reduce this occurrence.

Multiple-Threat Pedestrian Crash Illustration

Additional attention is warranted at the conditions that resulted in the one fatal pedestrian crash on the corridor. By state statute, all traffic must stop for a pedestrian at any crossing location. A legal crossing location is any marked crosswalk or any intersection. The current

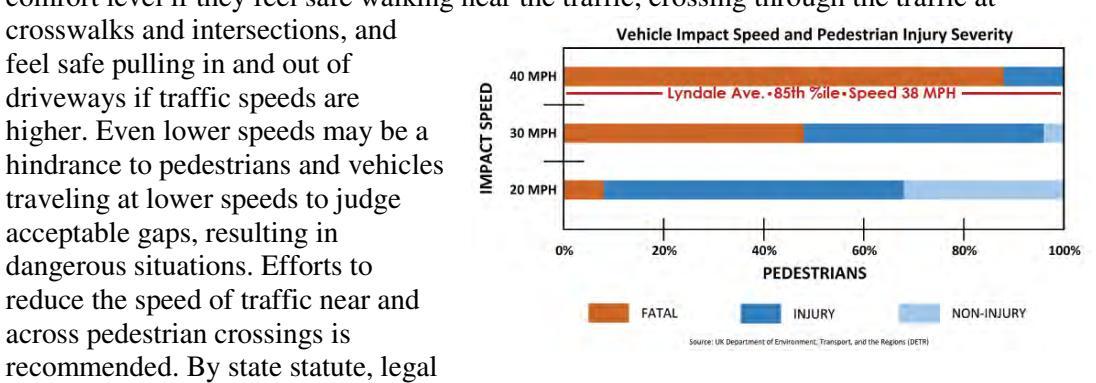
The speed of vehicle traffic can have a direct impact on pedestrian and bicyclist safety. As indicated below, lower speeds are more conducive to pedestrian safety. The maximum 85th percentile speed is shown on the figure below. Public perception of traffic speeds is also an important factor. The speed of traffic from a pedestrian or adjacent homeowner equates to a comfort level if they feel safe walking near the traffic, crossing through the traffic at

Traffic speeds can be reduced on the corridor through lane narrowing or adding raised features such as medians or curb extensions. Providing for additional features closer to the roadway also can affect traffic speeds by making the roadway environment feel narrower, resulting in lower speeds.

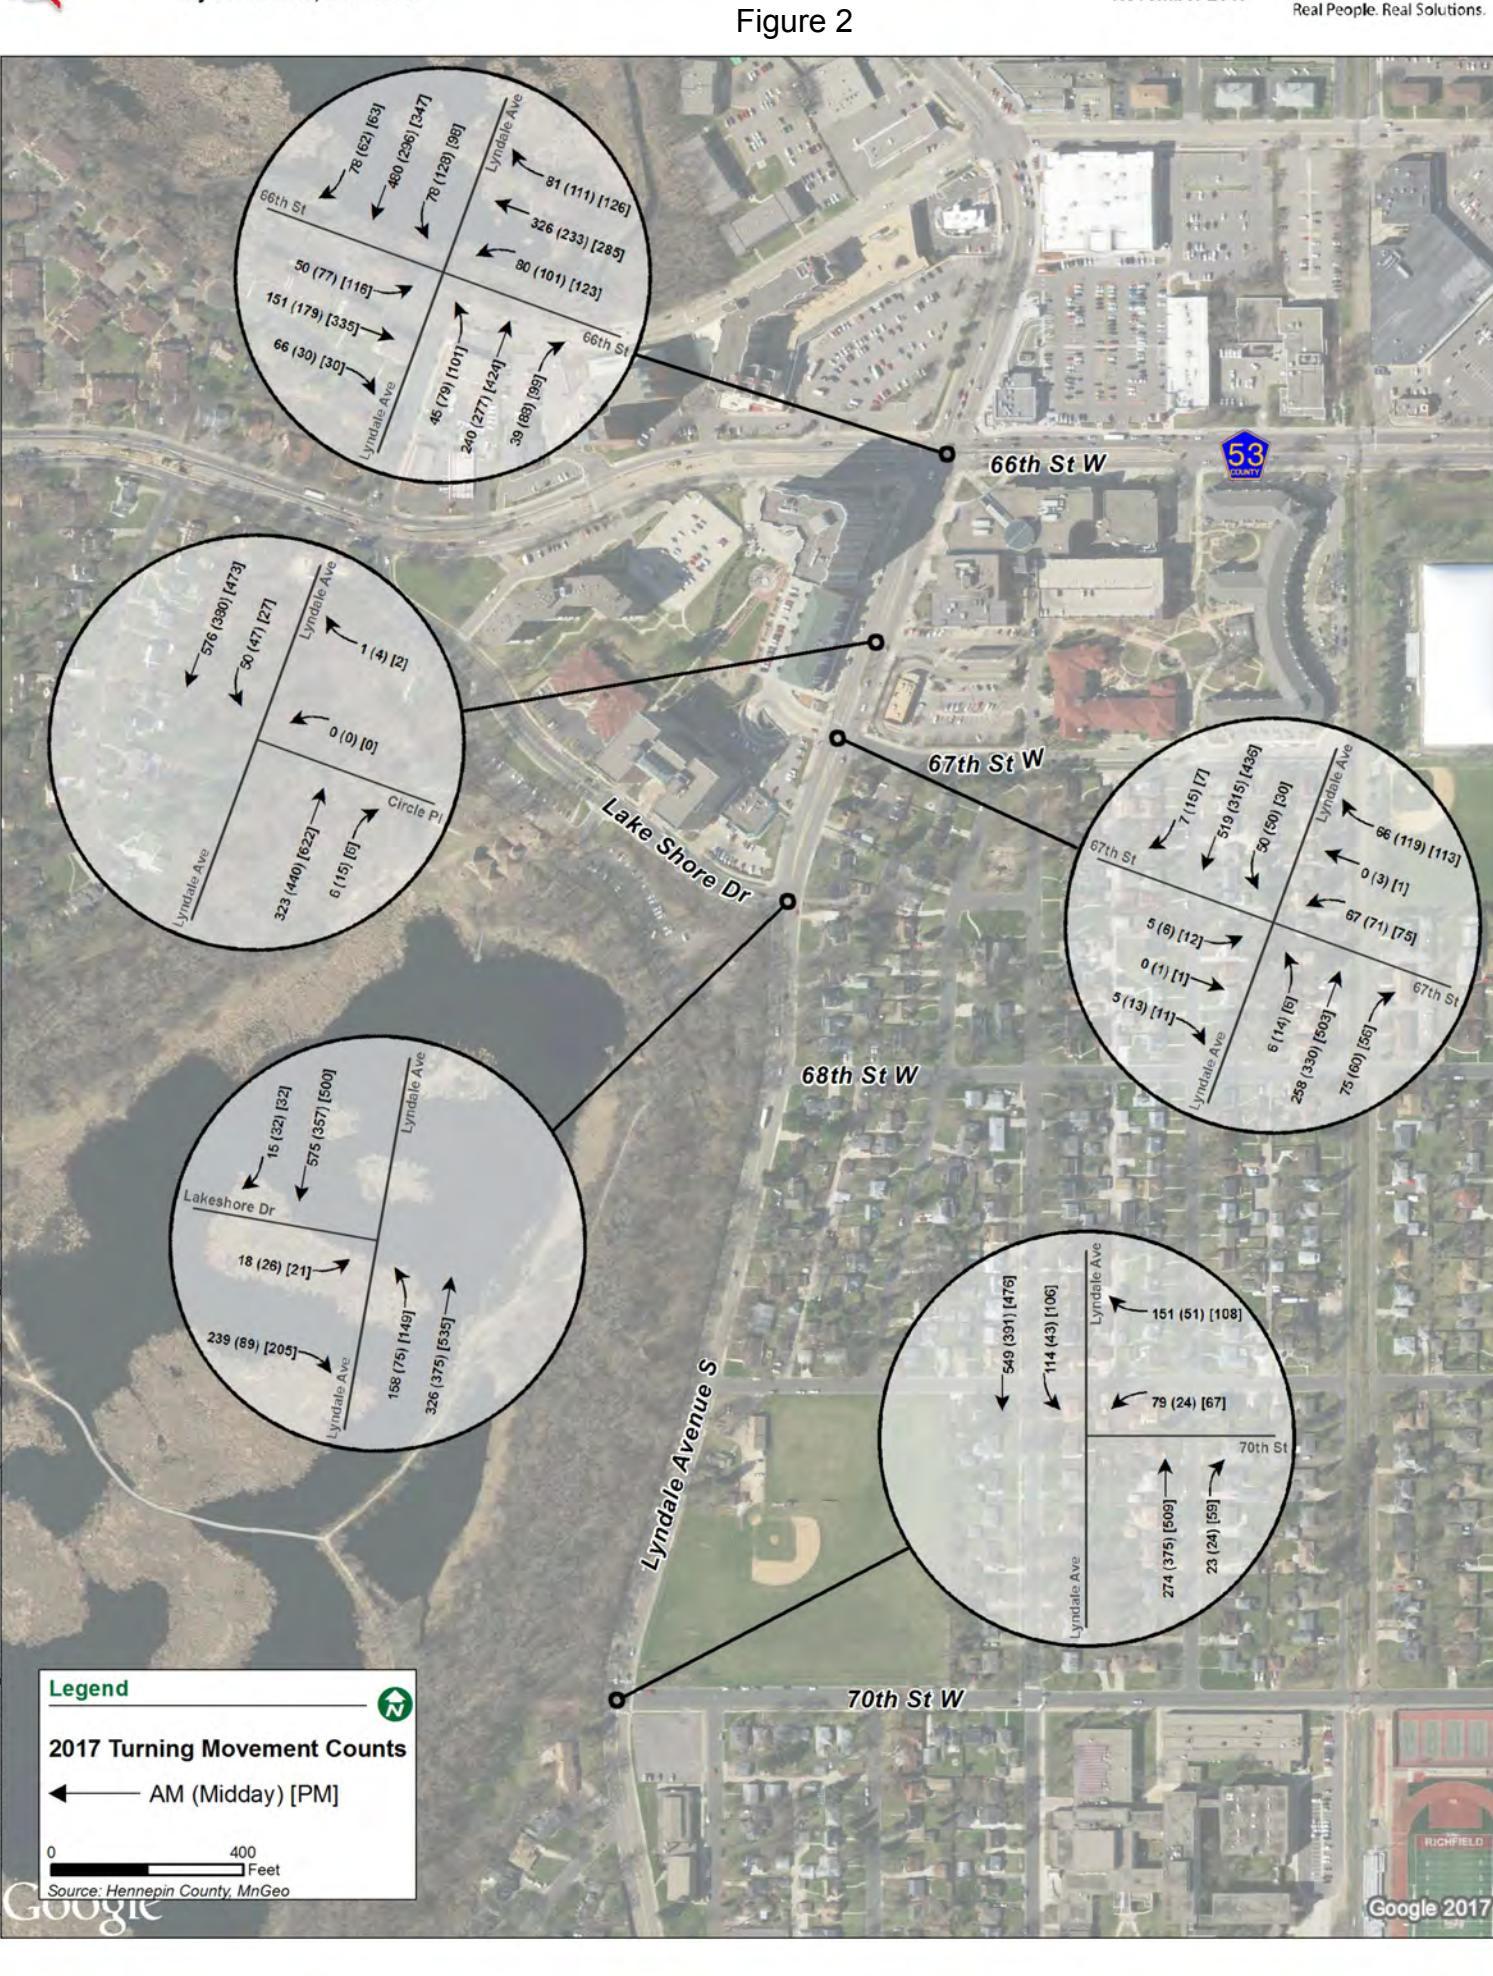
Existing Turning Movement Counts (South)

The peak hour turning movements can be found attached.
